Urban development in Londinium, AD 50 to 120: Leadenhall Court excavations 1984-86

Gustav Milne
Paul Wootton

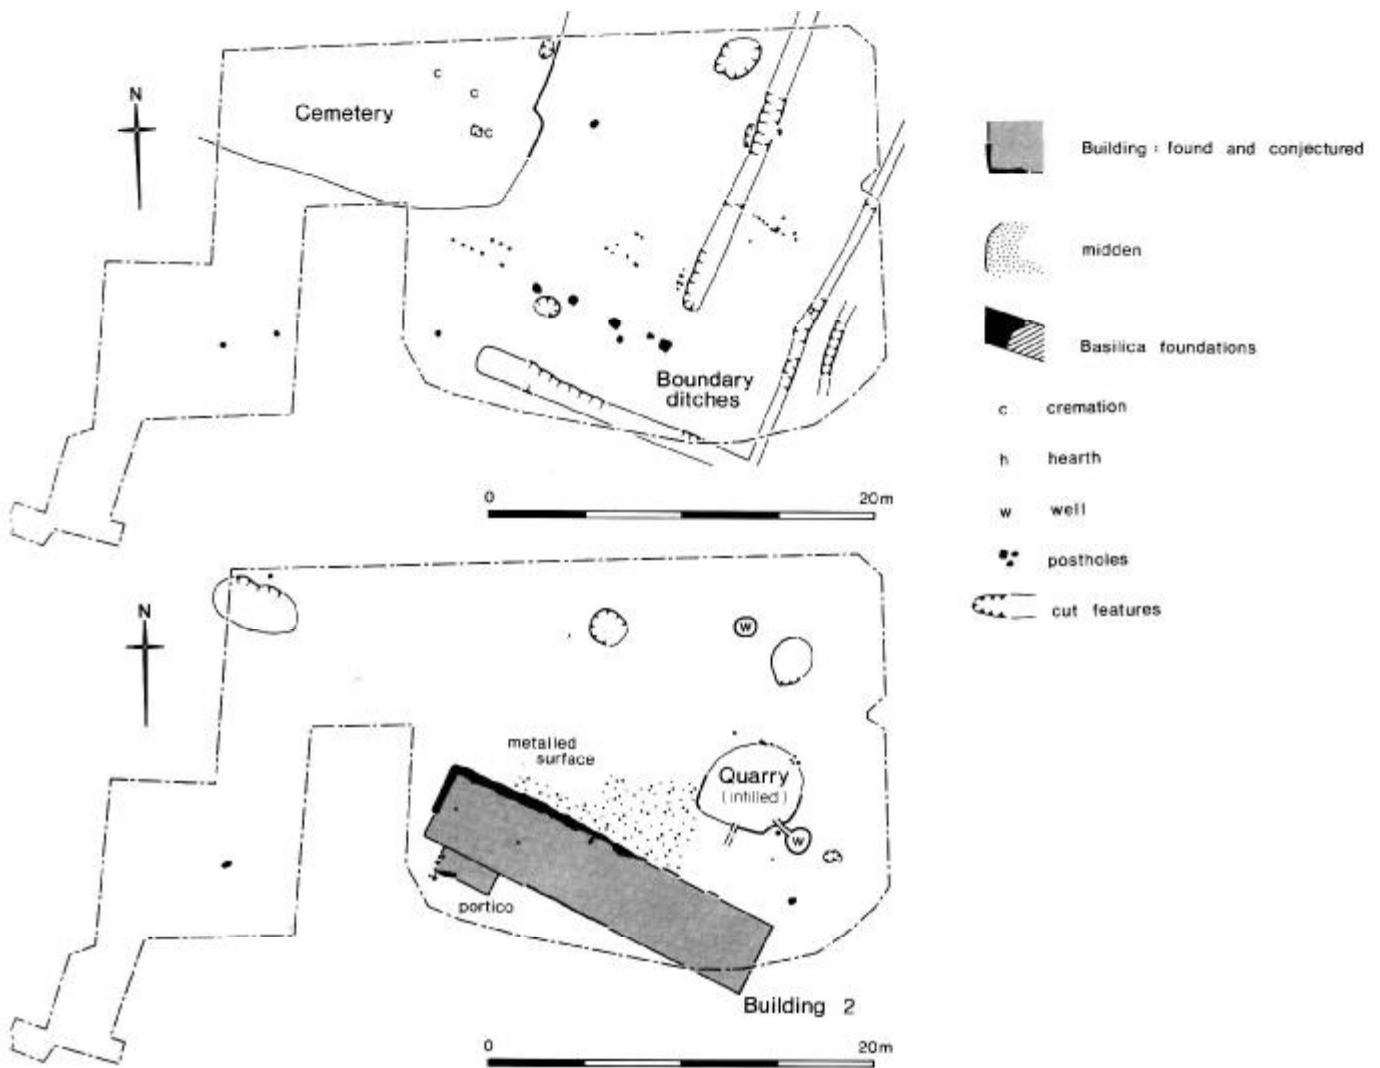
Fig. 2a: beyond the town boundary: plan of northern half of the site in the mid 1st century, with a small cremation cemetery and ditched enclosures.

Fig. 2b: ribbon development: the settlement encroaches over the former extra-mural area, with introduction of buildings fronting street to the east, beyond the limit of excavation.

Further boundary/marker ditches were dug on a similar alignment to the ones they replaced (Fig. 2a). The quarry floor of the preceding phase was now used as a cemetery, in which several cremation urns were discovered (Fig. 3). Under Roman law, cemeteries occupied positions outside the limits of urban settlement, in contrast to medieval parish graveyards. Subsequently, holes resulting from tree removal and other intrusive features were infilled when an extensive brickearth slab was laid to level the ground. Building 1 was then constructed along the alignment of the previous ditches, at the eastern end of the site in Area S, and was represented by a series of foundation trenches. It had at least three rooms, of which the best preserved measured 7m (N-S) × 3.5m (23ft × 11½ft). A small pit to the south of the structure may have functioned as a latrine. The cemetery and a large area to the west of the buildings were covered by an extensive domestic midden. Taken together, these features indicate a change in the function of the area, from one on the periphery of the town to one over which settlement was encroaching. These structures were demolished and a quarry was dug, presumably to extract brickearth for building.

Building 2 was then constructed (Fig. 2b). It was aligned E-W and was at least 18m long by 2.5m wide (60ft × 8ft). A series of post-holes on the south side of the building's west end suggests the presence of a verandah or portico marking an entrance. Two wells were dug and a metalled surface was laid to the north of the building, partially sealing the infilled quarry. The latter had been surrounded by a fence, the line of which had been defined by post-holes.

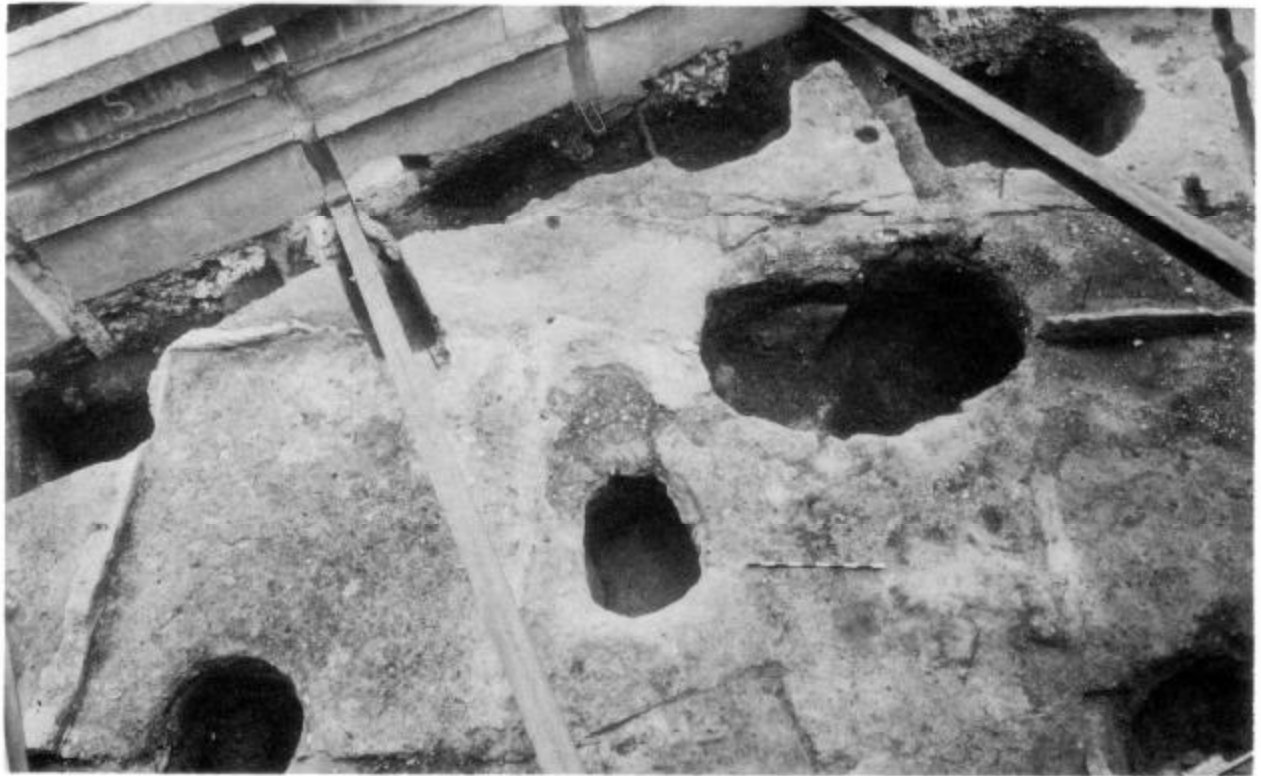
Fig. 6: part of Building 10 to south (top) and Building 12, in which $5 \times 100\text{mm}$ scale rests. They are separated by a narrow gravel alley, and are cut by later pits. Outline of thin brickearth and timber walls defined rooms no more than 4m (13ft) wide. Easternmost room in Building 12 (to left of scale) later demolished and sealed beneath midden deposits (cf Fig. 10).

The second phase of development (Fig. 4b) saw the buildings of this new formalised layout repaired and in some cases rebuilt. In the north, Building 12 (Fig. 6) replaced Building 11, while in the south Building 18 replaced Building 7. The area to the east of the site remained a dumping ground to which all alleyways from the main street led. To the east of the site in Area S the small Building 21 was constructed. Since the midden-like material found inside it appeared to have accumulated shortly after its construction, this outbuilding may have functioned as an animal enclosure.

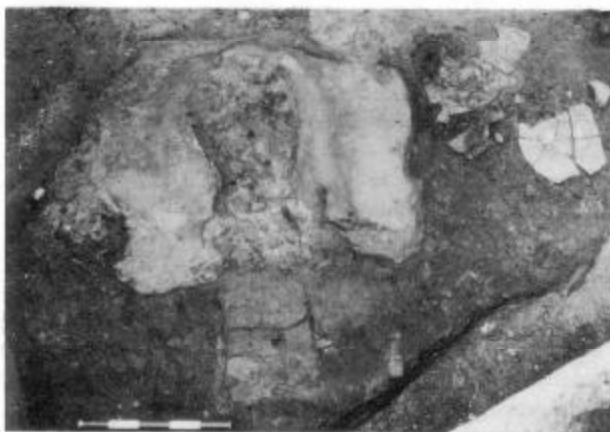
Fig. 5: Building 7: hearth with tile apron (next to $5 \times 100\text{mm}$ scale) and brickearth superstructure built directly against brickearth wall footing, visible at top of photograph.

An alleyway 1m (3ft) wide separated Building 6 from a structure to the south, Building 7, which extended both east and west beyond the limits of Area M. A 'bee-hive' oven occupied most of the only room excavated. It was larger than many of the other hearths or ovens discovered at Leadenhall Court, which were usually of the 'key-hole' type (Fig. 5). Evidence for

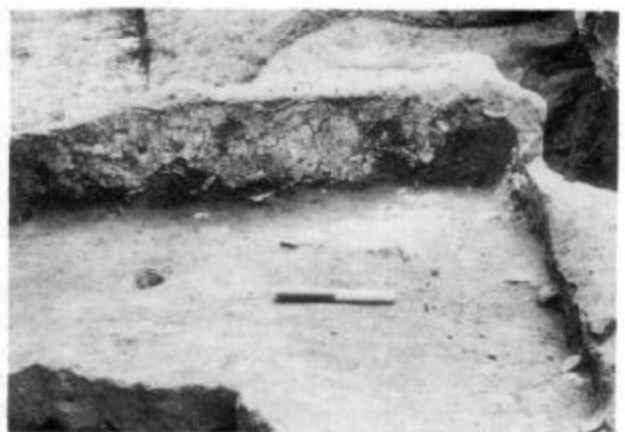
Fig. 7: Building 6: $2 \times 10\text{mm}$ scale rests in north-east corner of room. Note plaster rendering on internal face of wall footing.

Building 6 was also substantially repaired, with an extension built onto the east end of the property. The N-S aligned corridor at the back of the property was repaired and decorated with painted wall plaster (Fig. 7). Such quality of internal decoration contrasts significantly with that recorded in all the other buildings on the site, as does that building's large and complex plan. These facts suggest that, unlike its immediate neighbours, Building 6 should not be seen as an artisan dwelling. Subsequently more repairs were undertaken when a fire in the newly-decorated north-east corner of the building damaged much of the eastern end.

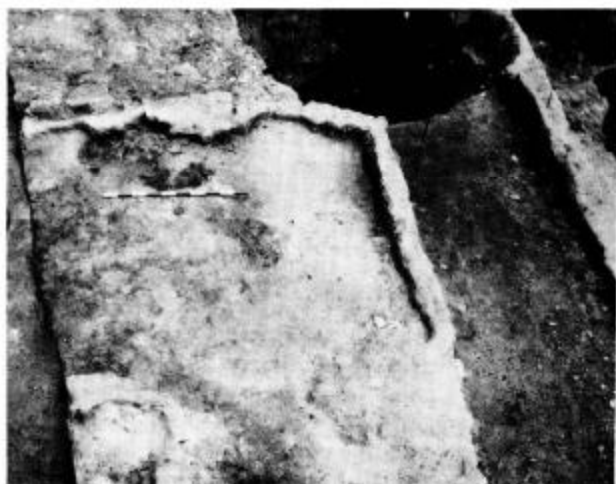
Fig. 9: Building 12 contracts. 5 × 100mm scale lies within easternmost room, with footings of brickearth walls to east (top) and south (right). Note hearth, and tiles marking position of cupboard to west, next to threshold opening onto narrow alley cut by later pits. North wall of Building 10 visible to south. Midden deposits dumped against east wall of Building 12 seal remains of the east room shown on Fig. 9.

However, occupation and activity in the north of the site did not cease immediately after the phase of contraction just described. Although Building 22 was demolished, three new structures were erected (Buildings 15, 20, 23) and Buildings 5, 10 and 12 (Fig. 9) were modified. This new layout is quite distinct from the previous development, and the occupation seems to be not only contemporary with, but also directly related to, the construction of the enlarged basilica. Since the new structures shown on Fig. 8b seem to function with the mortar-mixing pit and the area where ragstone for the basilica was prepared, they are interpreted as representing site huts, canteens and store-rooms associated with a

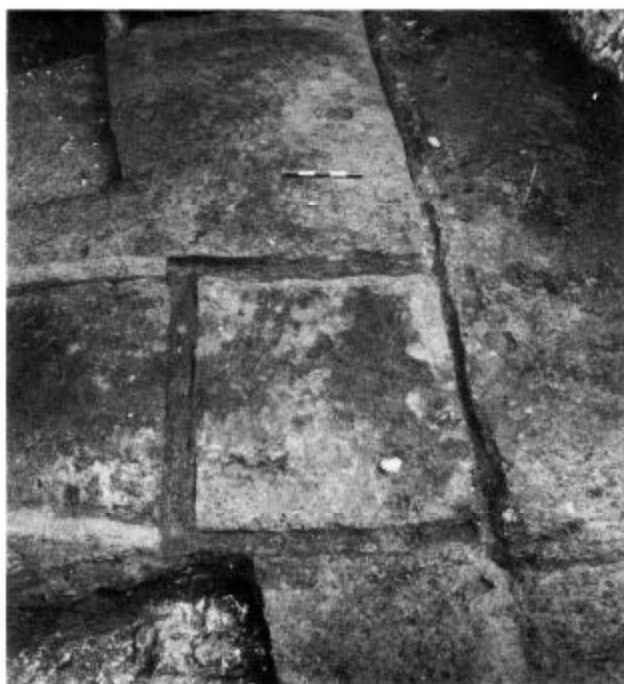
Fig. 10: Building 6: 2 × 10mm scale rests in one of the rooms defined by slots in which decayed traces of squared timber base-plates were recorded.

Buildings with a timber framework were also common in early Roman London (Fig. 10). A shallow construction trench was dug, into which was laid a timber base-plate with mortices cut into its upper face to support vertical timber posts, known as studs. On the Leadenhall Court site, fragments of decayed wood were all that survived of the base-plates, and few traces of upright studs were recorded. (Much clearer
