The discovery of Londinium's amphitheatre: excavations at the Old Art Gallery site 1987-88 and 1990

Nick Bateman

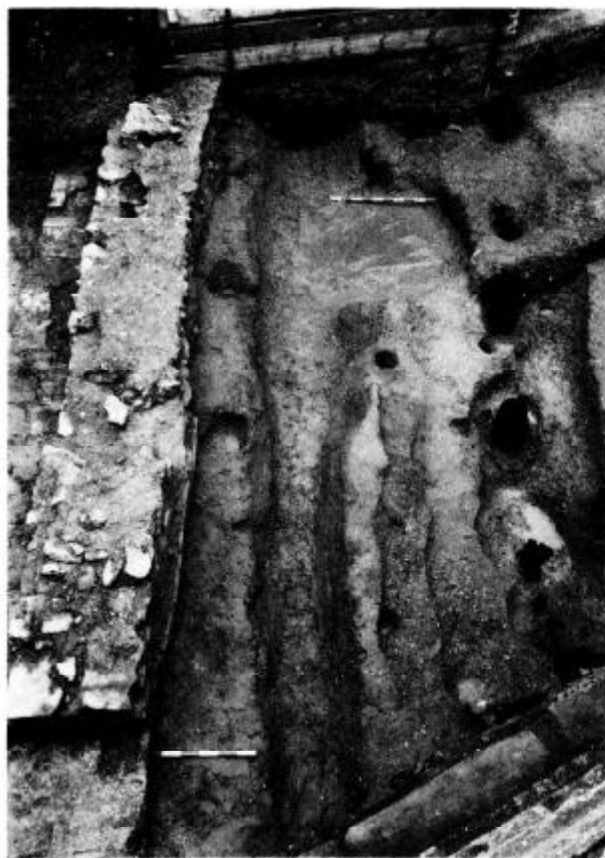
Fig. 2: 1st-century amphitheatre, showing the timber piles of the early amphitheatre. On the left is the arena wall.

The main element of this structure was the feature recorded in Areas A, E and H, comprising a row of substantial squared timbers set in a curving foundation trench, which may represent the remains of a timber wall or palisade⁵. To the west of this was a large open space in which were compacted gravel surfaces.

An entrance across a threshold defined by the large sill beam (Figs. 2 and 8) connected the open space with a subsurface room to the east. Part of this seems to have been provided with a planking floor, most of

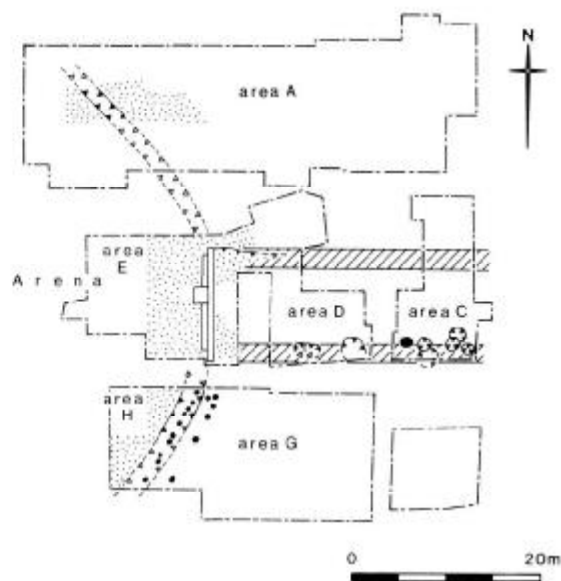
Fig. 3: 1st-century amphitheatre.

Pre-amphitheatre structures (Figs. 2 and 3)

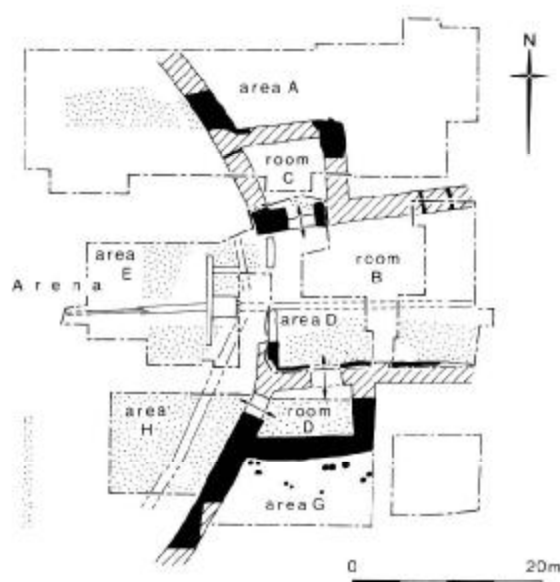
Fig. 4: 2nd-century amphitheatre as originally built.

Within the arena (Fig. 4), the first surface laid was a patchy *op sig* which was continued up the face of the arena wall as rendering. If the walls which defined the arena continued at the same curvature they would define an elliptical shape which would be unlikely to be less than c 100m (330ft) wide at its maximum⁹.

The 'entrance way' (Fig. 4) is so defined by the large gap separating the northern stretch of curving wall from its southern counterpart. The extent of the surfaces within indicates that the 'entrance way' must have continued beyond the eastern limit of excavation although the eastward extent of the walls was more ambiguous. The lowest and earliest surface comprised a thick deposit of large ragstones and tiles, the top of which was firm and compact. In spite of being perhaps more distinctive than any later surface, in Areas F and B it was not traced where the succeeding surfaces were recorded.

Two small antechambers (Fig. 4) were built on the north and south sides of the wide 'entrance way'. They were quite different in size and neither was rectangular, but both had doorways with timber thresholds giving access to the 'entrance way'. In addition the south chamber had a stone-flagged threshold leading onto the surfaces of the arena (Fig. 6), and the north chamber may have had a similar arrangement.

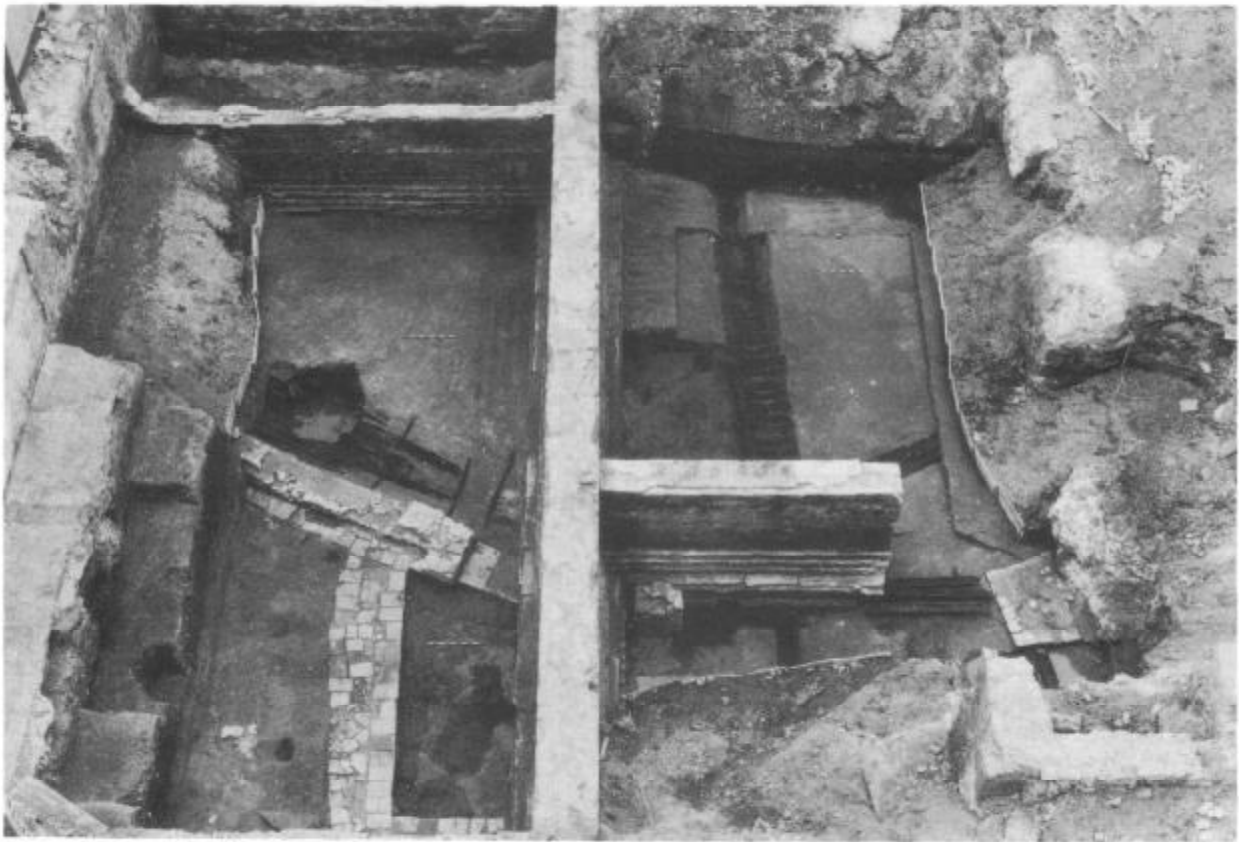
Fig. 5: looking west over the amphitheatre. The main entrance way (between arrows) is slightly obscured by the Victorian foundation. The central timber drain can be seen extending west through the arena.

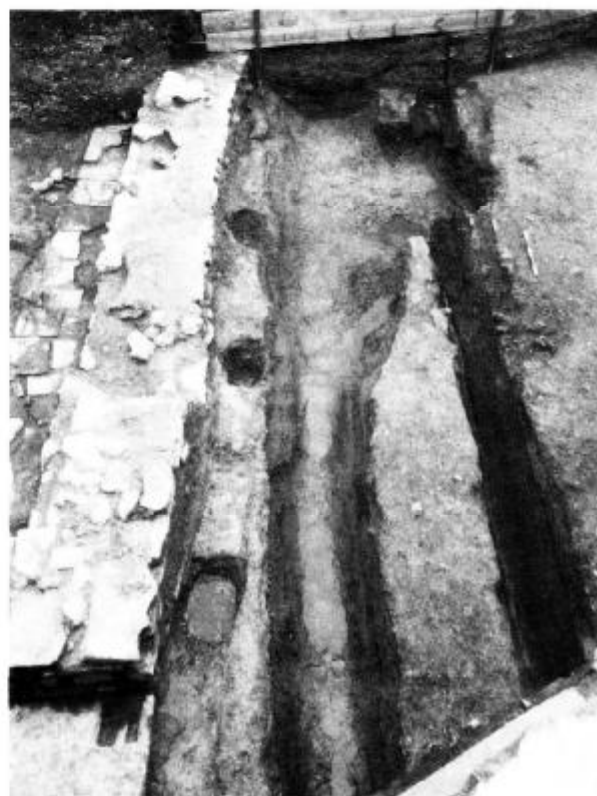
Fig. 6: on the left is the tile-built arena wall and the later ragstone rebuild directly over it. In the bottom corner is the stone threshold leading into the arena. The timber lid of the first peripheral drain is on the right and the gully of the second peripheral drain lies between them.

The peripheral drain was also replaced but in this case not only was the new drain in a slightly different position (Fig. 6) but there was conclusive evidence for its existence in Area A as well. The timber lid of this drain did not survive in the north of the site.

The curving arena wall was rebuilt at least once. In Areas G (Fig. 6) and less certainly in Area D, there were surviving masonry courses which did not appear to be part of the initial build of the amphitheatre, and

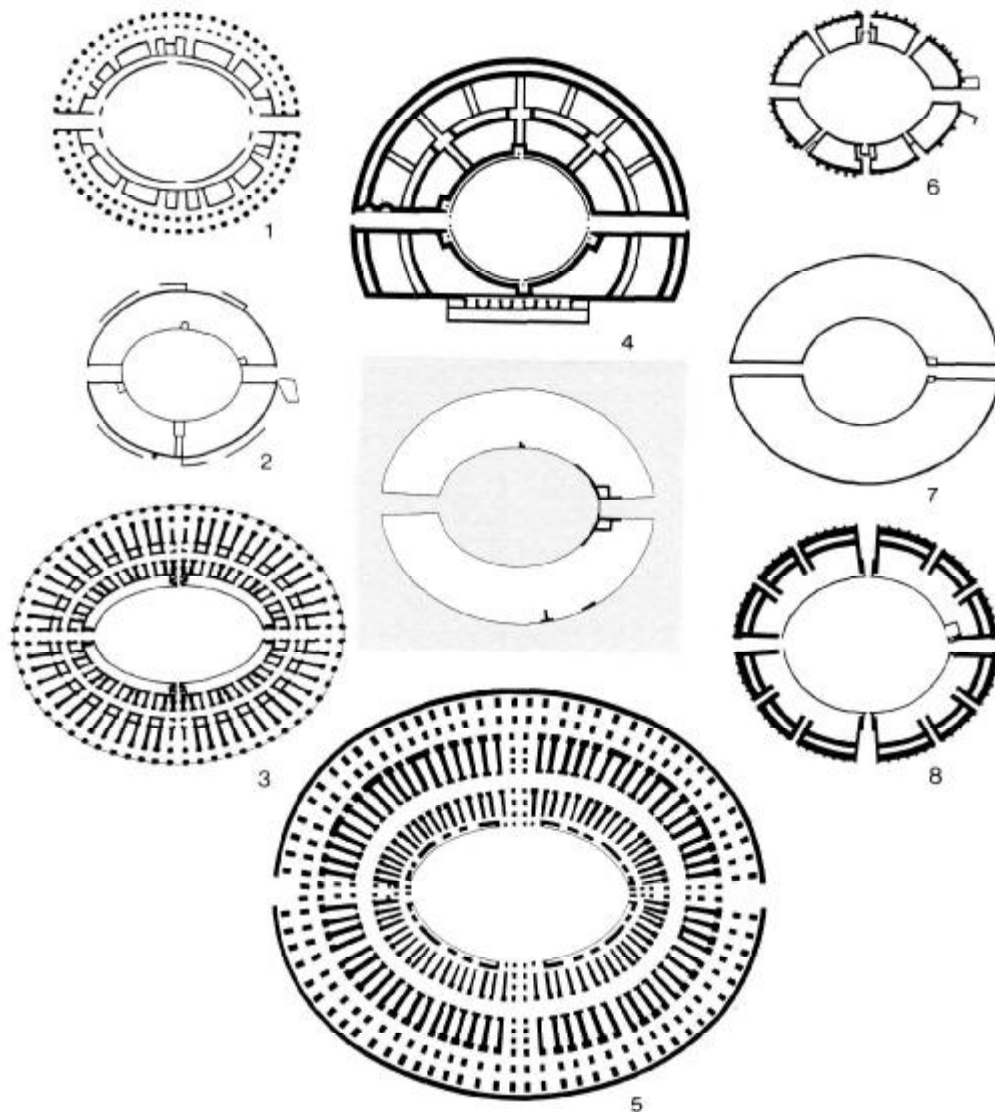
Fig. 7: the London amphitheatre with comparative forms from Xanten, Germany (1); Martigny, Switzerland (2); Arles, France (3); Lutèce, France (4); Rome (5); Caerleon (6); Cirencester (7); and Chester (8).

the building was an amphitheatre, the large open space being the arena; Room B being the ceremonial 'entrance way' into the arena; Rooms C and D being changing rooms or shrines giving access to both⁸ (Fig. 7).

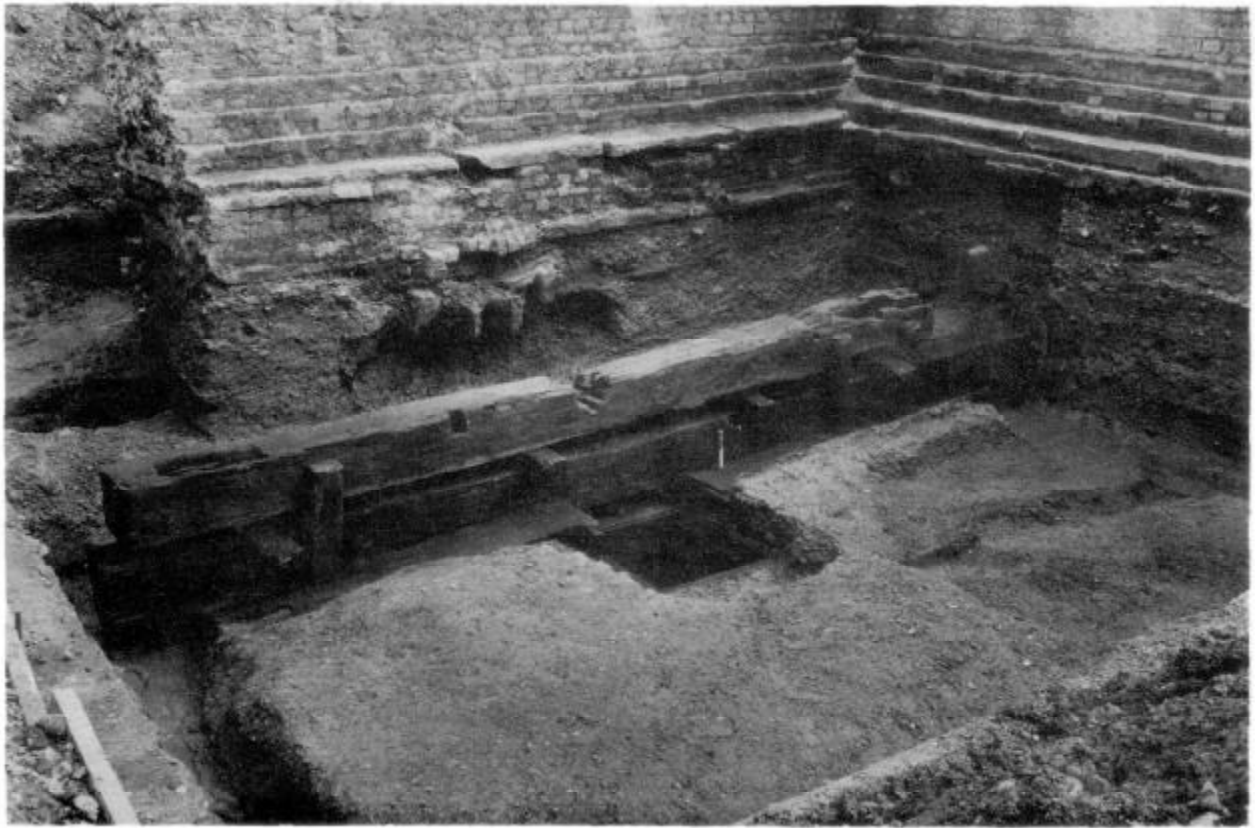
Fig. 8: the timber sill of the 2nd-century amphitheatre entrance way supported on small wedges over the sill of the earlier timber amphitheatre. In front of the latter is its related timber drain and collecting tank.

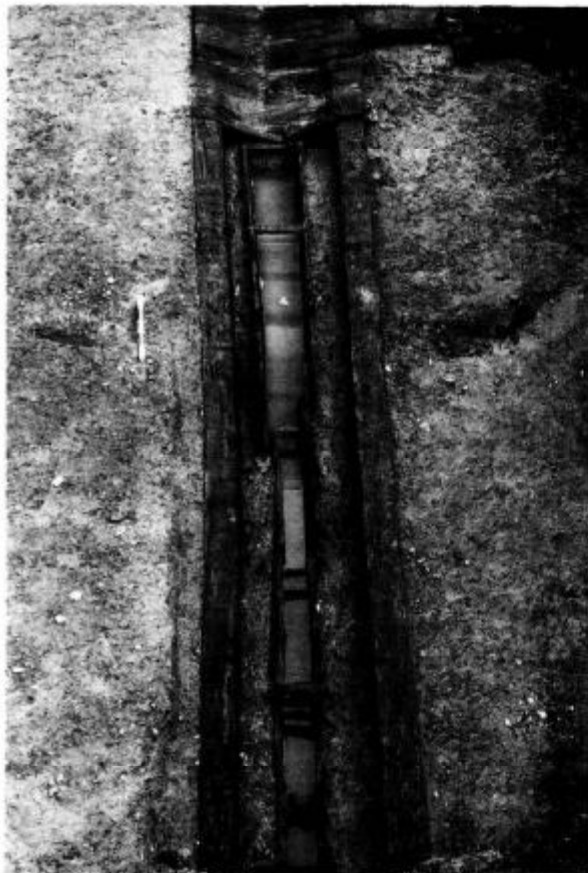
Fig. 9: view down the central timber drain. The drain sides are held apart by small cross braces. Part of the planking lid can be seen at the top.

On the west side of the beam was a subsurface timber-lined drain of very unusual construction which fed into a solidly-built timber water collecting tank. Since the drain was co-extensive with the timber sill, it may have served to channel off ground water (Fig. 9).

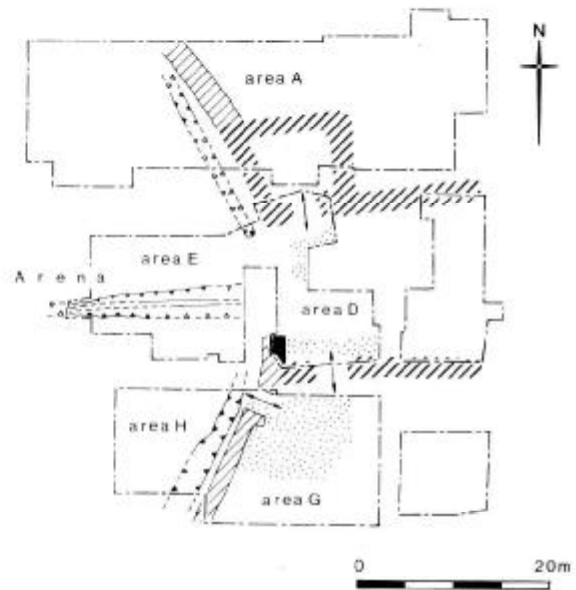
Fig. 10: 2nd-century amphitheatre modifications and rebuilds.

Rebuilds (Fig. 10)

in Areas G and A there were later robber cuts marking the presence of this rebuild. The rebuild was reduced in width to $\approx 0.80\text{m}$ (2ft 7in) and was directly associated with one of the higher surfaces in the 'entrance way' and the arena.

Structure over robbed out Room D of amphitheatre (S7) (see Fig. 10)

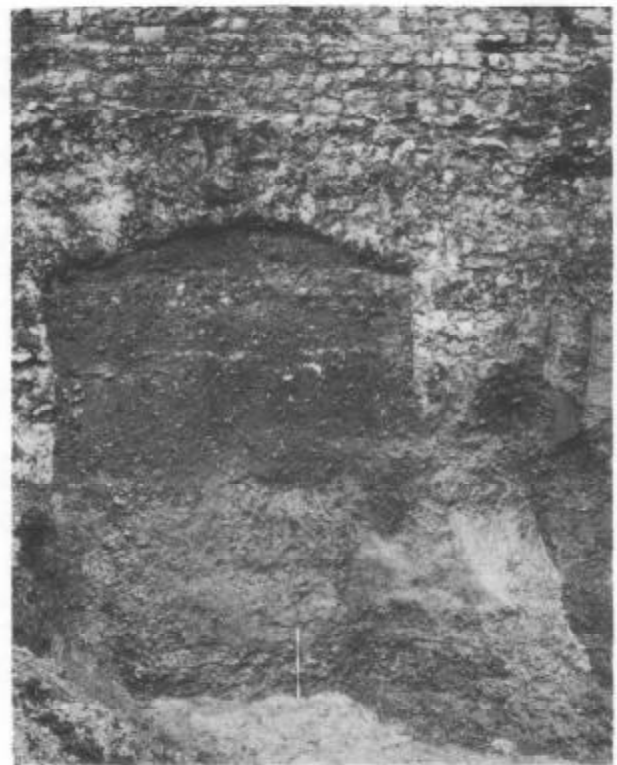
Fig. 11: the scale rests on the remains of the arena wall (1). Directly above the wall are the robber trench infills (2) which are themselves sealed by ‘dark earth’ (3) and later medieval surfaces (4).

Final robbing of amphitheatre walls (OA7) (Fig. 11)

Evidence for the final robbing of the reduced width circular wall of the arena was found in Areas A and G. It appeared to be later than the latest activity in the arena but before the whole of what had previously been the amphitheatre was sealed by thick ‘dark earth’

The whole site was sealed with a thick deposit of largely sterile dark grey silts with little or no destruction debris in them (Fig. 11). The mechanics of the deposition of this layer remain uncertain whether accumulating naturally or as a single dump. The deposit has been provisionally identified with the so-called ‘dark earth’ deposit which seals much of late Roman London. There was no evidence for structures or buildings laid out immediately on the top of this deposit. There was however a number of pits which appeared to have been cut from this level. The whole site seems to have been used as a large open external

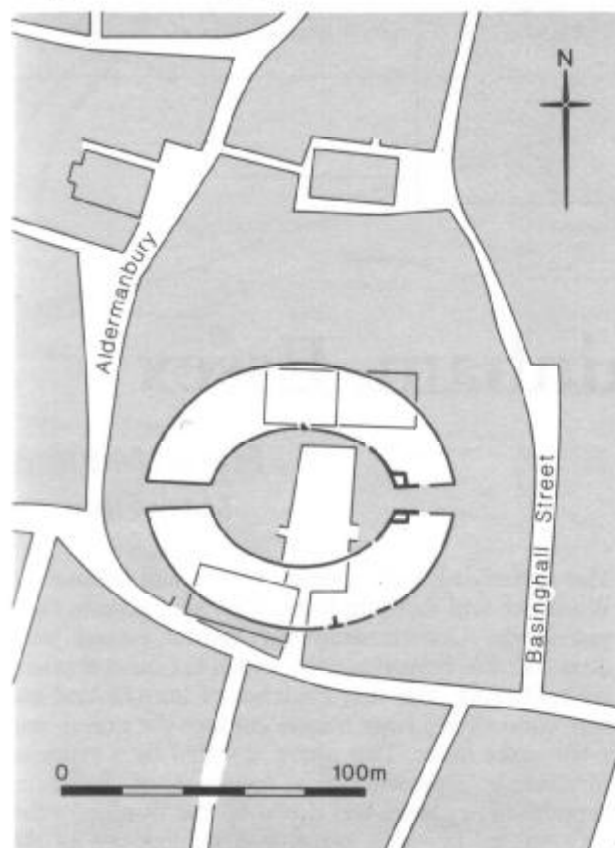
Fig. 12: the position of the amphitheatre as located by the excavations in 1951¹⁵, 1985 and 1987, in relation to the Guildhall (13th century and possibly earlier) and the late medieval street pattern. These features seem to respond to the shape of the amphitheatre and may indicate that elements of the Roman structure were still surviving in the early medieval period.

Amphitheatre influence on later topography (Fig. 12) It is interesting to note that the GAG 87 site has a long history as an open area: from the time when there was an amphitheatre arena through to the early medieval period (not discussed here)¹³. This appears to suggest some kind of continuity from the arena. Furthermore it has been noted that early street plans of this area of London, and in particular Leake's map of 1666, show a distinct curvature of the adjacent streets, Aldermanbury and Bassishaw, around some large space of which the Guildhall lay at the centre¹⁴. The fact that the earlier of the crypts of Guildhall, which has itself been suggested as the remains of the 13th century Guildhall, lies directly over the projected lines of the amphitheatre walls, seems to add further weight to the suggestion that the ruins of the
