Replicas and wrecks from the Thames area

Damian Goodburn

Mark Redknap

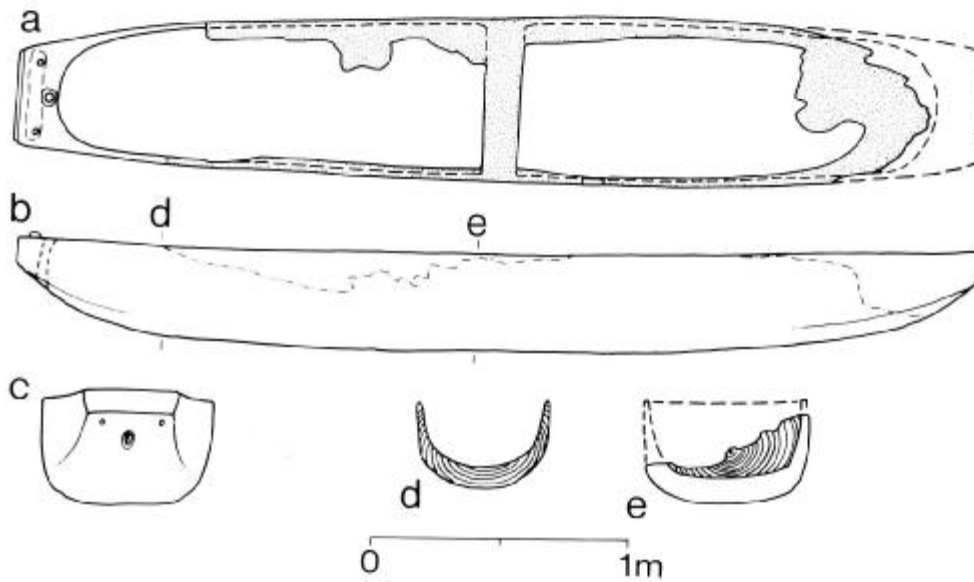
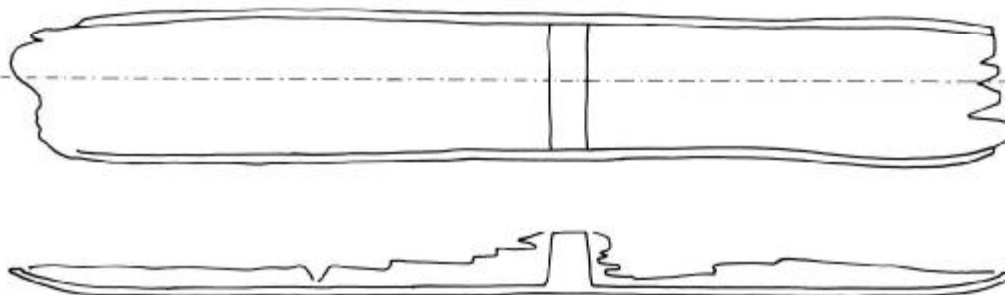
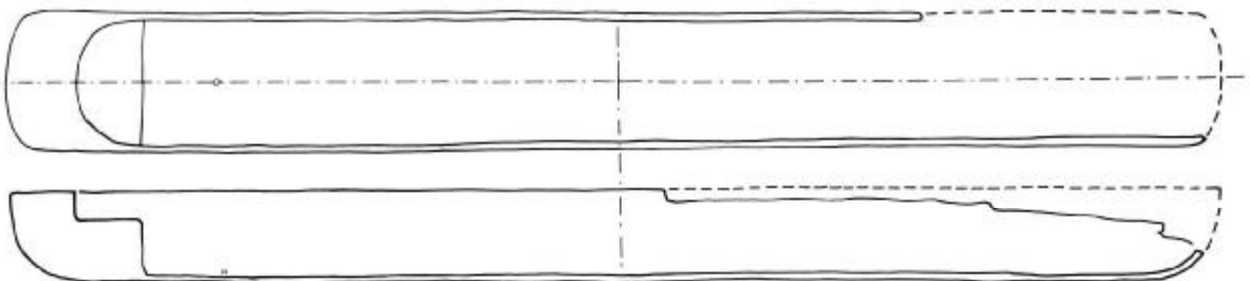
Fig. 1: Reconstruction of the Clapton Logboat (based on drawing by P. Marsden, Museum of London), and other logboat finds from the Lea at Walthamstow (length 15 feet) and Royal Albert Docks (redrawn from T. D. Kendrick 'Dugout canoes in the British Museum' *Antiq Journ* 21 (1941) 74-5).

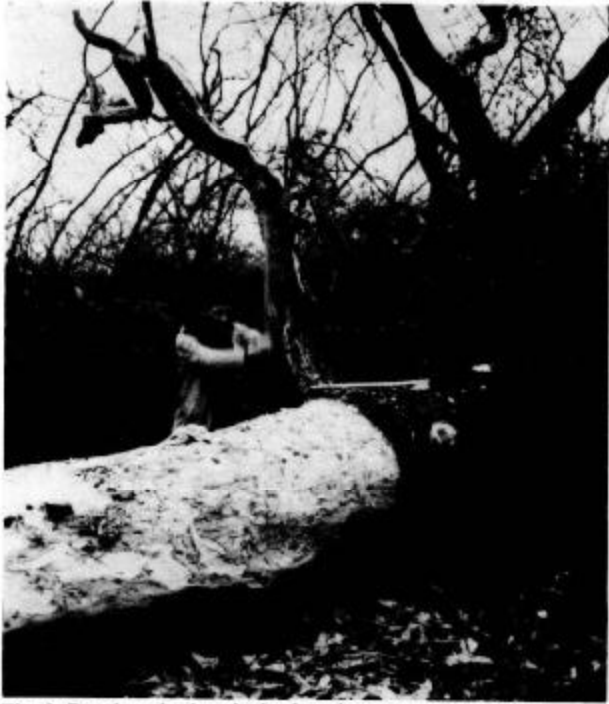
Fig. 2: Day 1, stripping the bark and cross-cutting the log.
(Photo: M.A.S.)

1. Tree selected with an allowance for the removal of sapwood.
2. Bark and branches removed (Fig. 2).
3. Stem cross-cut most of the way through using large axes (Fig. 3).
4. Fashioning the boat in an upside-down position, most of the waste being removed from the future bottom with axes to crosscut and split out waste in large lumps.

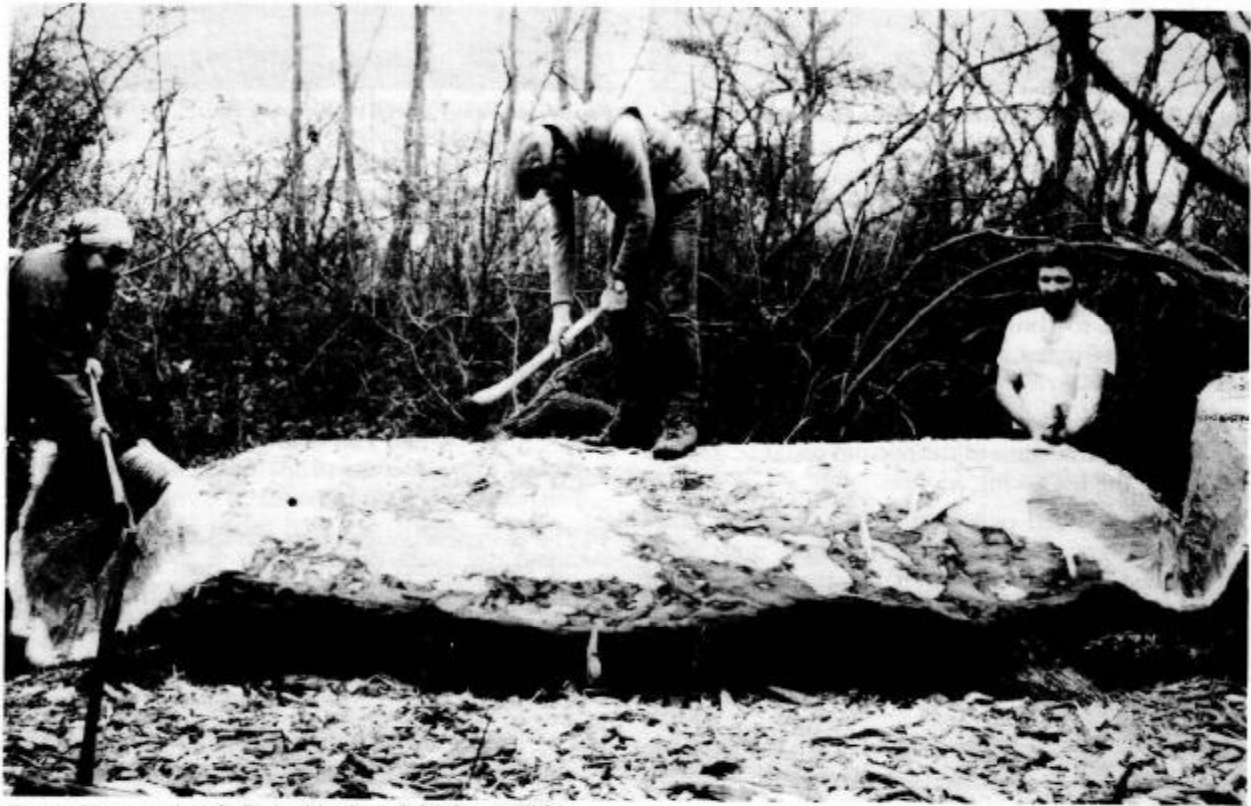
Fig. 3: Cross-cutting the log to length and shaping outside.
(Photo: M.A.S.)

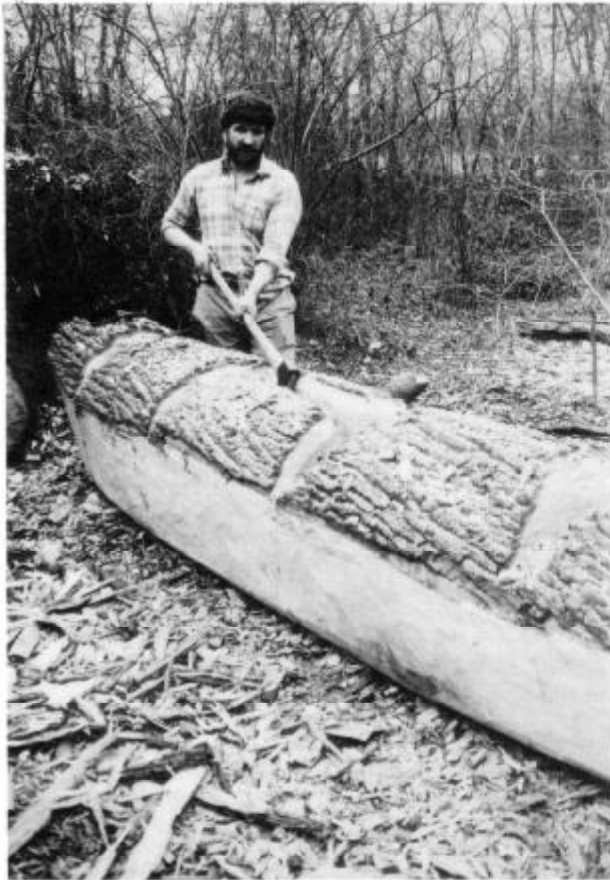
Fig. 4: Removing waste from the top using groove and splinter technique. (Photo: M.A.S.)

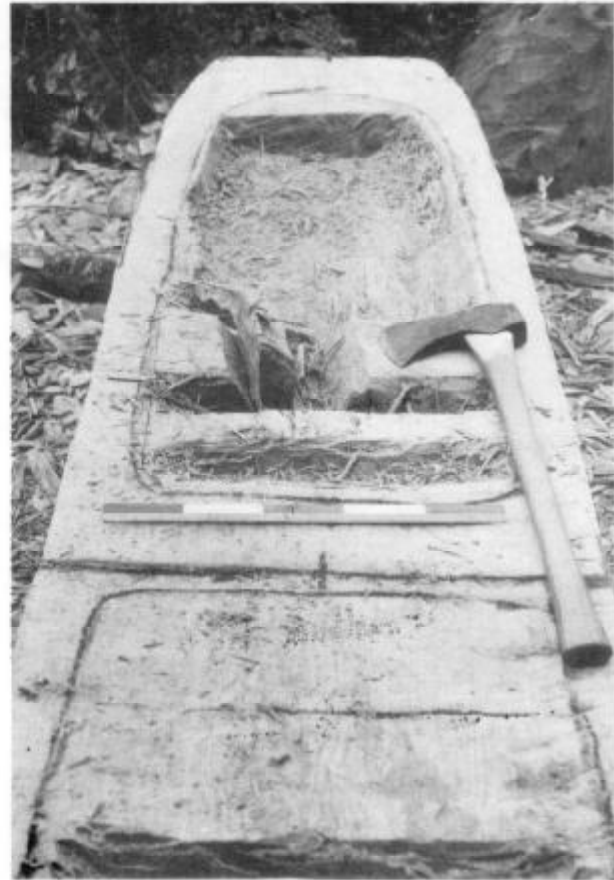
Fig. 5: Hollowing process begun using axe. (Photo: M.A.S.)

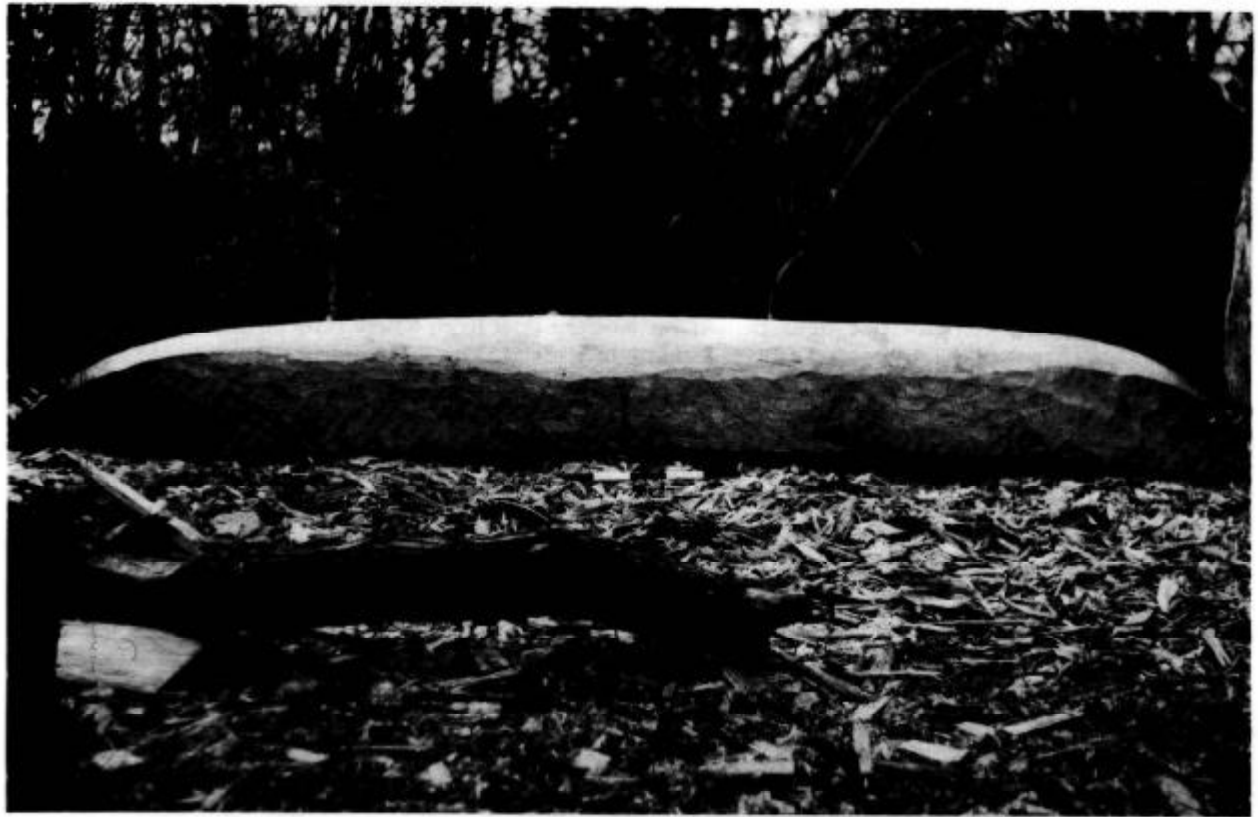
Fig. 6: Final shaping of the bottom and sides.
(Photo: M.A.S.)

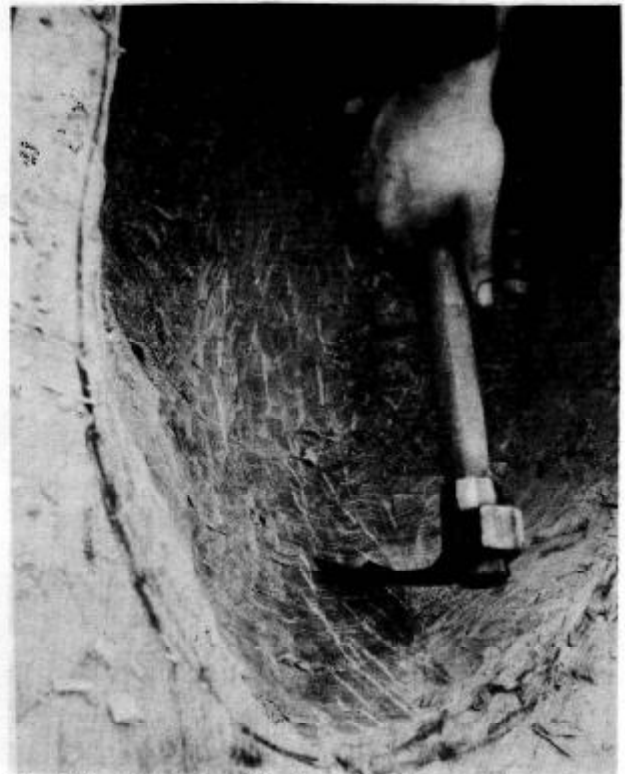
Fig. 7: Final hollowing of the bow using adze.
(Photo: M.A.S.)

17 Inside of boat roughly finished using hatchets on the sides and bulkhead, and gouge adze on the bottom (Fig. 7).

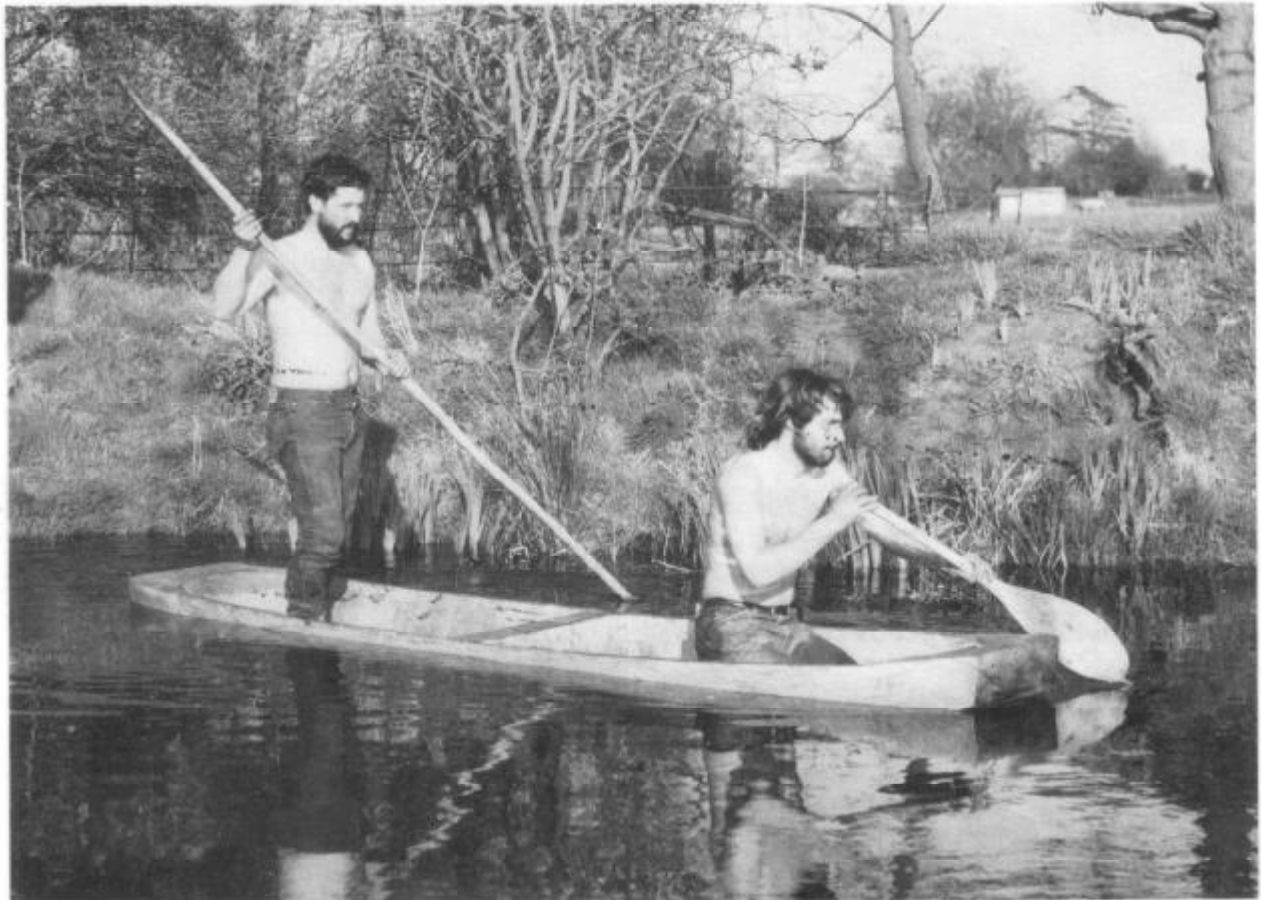
Fig. 8: First trials with punt pole and paddle.
(Photo: M.A.S.)

Standing up and punting was fairly easy despite the narrow beam of the boat, as the thick heavy ends helped to damp down pitching, and permit boarding end on. Punt poles were fashioned from ash donated by the Norman family, and several paddle replicas of the late Saxon oak paddle from Southwark¹⁰ together with wooden bailers were made. Paddling was found to be most effective by one crew, sitting in the stern of the boat from where boat direction could be easily controlled. The most practical load would have been equivalent to two average-sized adults with some equipment. Freeboard (the height of the side above the water) was $\approx 0.15\text{m}$ (6in) with one adult on board.

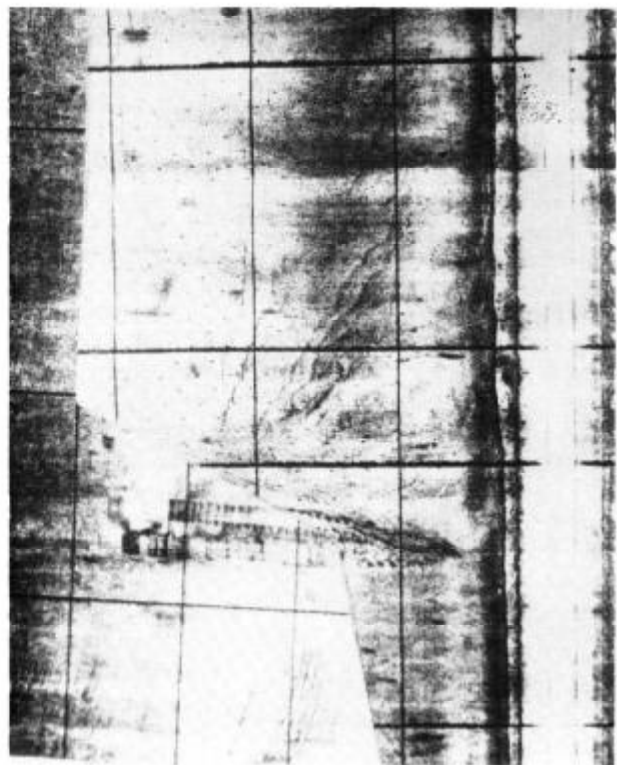
Fig. 10: Side-scan sonar image of an unidentified wreck emerging out of Margate Sand in the Thames Estuary. Without a national programme of survey and wreck management, such sites remain prone to escalating threats of indiscriminate salvage, erosion and decay, damage from dredging and mineral extraction, and souvenir hunting.
